BISON PRECAST

GUIDANCE NOTE

Stacking of beams - 20 August 2018

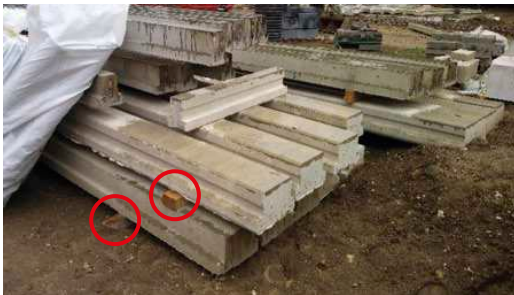
Figure 2 – Poorly stacked beams

This guidance note is aimed at giving advice to hauliers when offloading beams and to site if stacks of beams have to be moved. To avoid deflection issues with beams it is important for the timber bearers to line through and for them to be positioned 300mm from the end as shown in figure 1 Failure to comply with these requirements will result in excessive camber of the beams which may render them unusable and will result in rejections / claims. Figure 2 and 3 show examples of poorly stacked beams and the consequence.

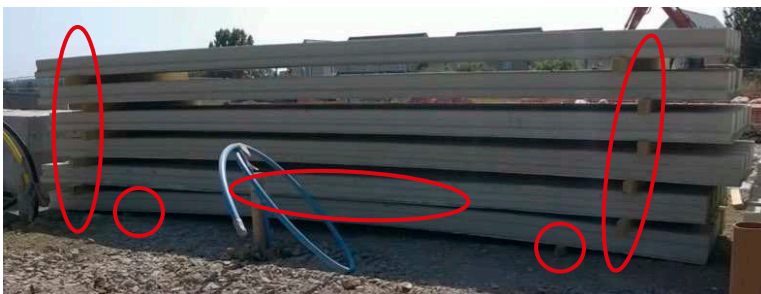
Figure 3 – Poorly stacked beams resulting in severe camber on bottom of stack

In addition, when handling beams there is a maximum lift of two stacks at any one time to mitigate over stressing the bottom lift. Failure to comply with this requirement can result in stress cracks along the top surface of the beam and excessive camber with possible rejections.
